Marine Gear Type Couplings in Service

D.L. Saunders-Davies

Shell International Marine Limited, London, England.

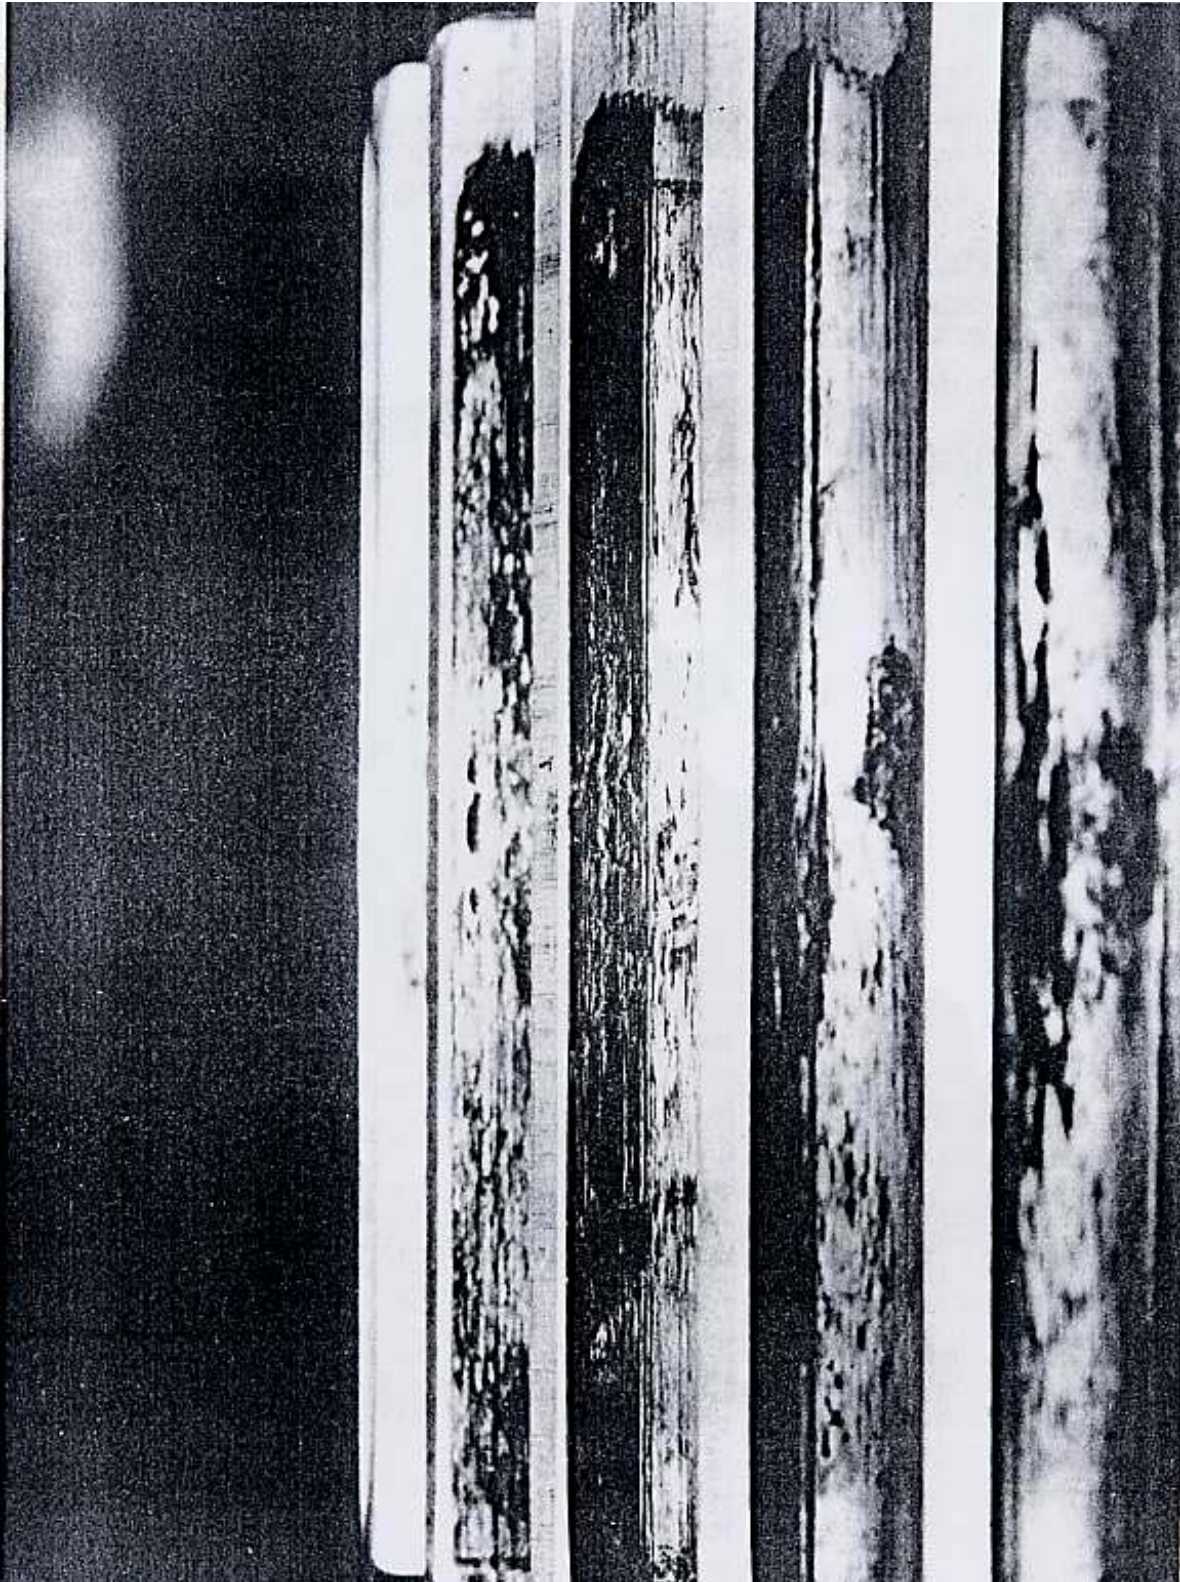
Figure 1

In later ships, built in 1966 and after, coupling performance has been markedly improved, but there have been cases of early replacement due to excessive wear and surface damage. One example is illustrated in Figure 1, which shows axial scoring and heavy fretting after only about 2 years in service. Some, but not all, of the damage was due to alignment being outside specified limits. In this and another case which was also subject to extensive misalignment, the design was altered by introducing barrelling and the tooth surfaces were nitrided. Subsequent performance in these and all other ships having the same modified couplings has been completely satisfactory. In one other design, coupling condition was indifferent after 2 years in service, mostly at reduced power. It is likely that both HP and LP couplings in this ship will be replaced after a further 2 years service. The manufacturer's opinion in this case was that at the time of examination the couplings were satisfactory. Surface damage, again scoring and fretting, was considered as being normal, and it was stated that such damage generally stabilized, getting no worse in subsequent service. This tacit acceptance of indifferent performance is not shared these days by other manufacturers.

Axial scoring and fretting

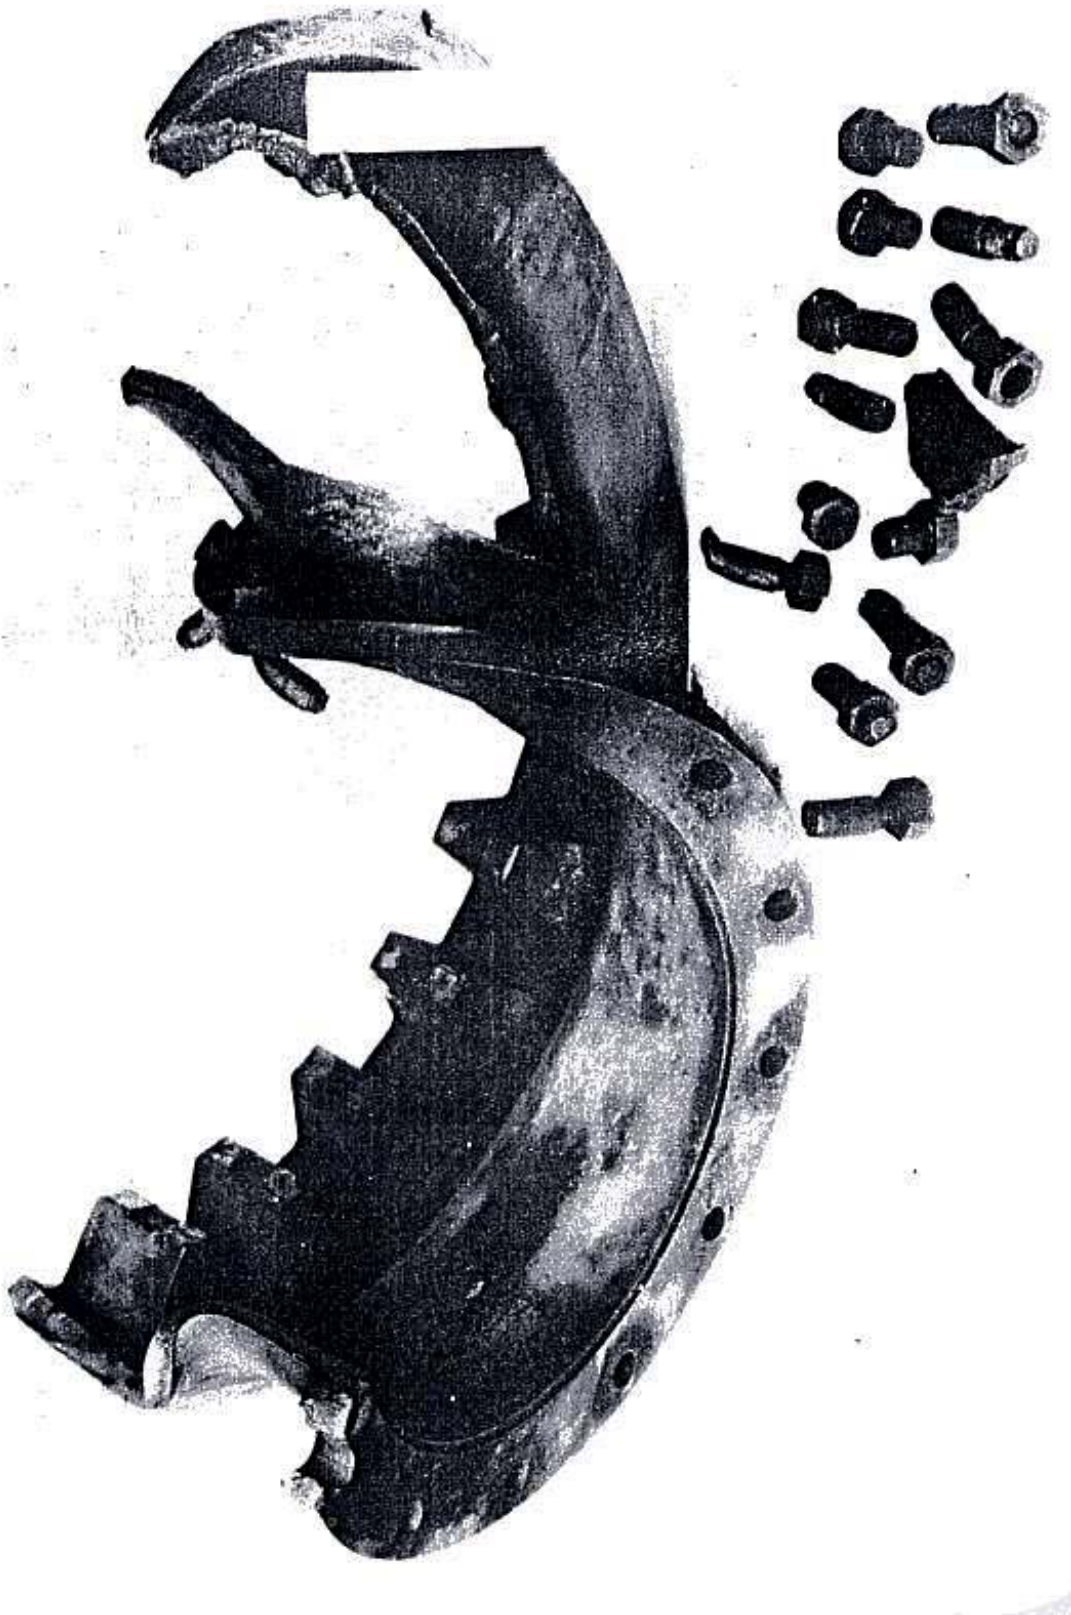
Figure 2a

As to safety, accidents have happily been rare. One occurred in 1962 when a coupling failed (see Figures 2a and 2b), leading to a disastrous engine room fire, serious injuries and loss of life. The cause of failure was the development of a corrosion fatigue crack originating between two teeth on the inside of the pinion coupling sleeve. Examination of the failed components suggested that the failure was caused by the combined effects of large out-of-balance forces due to heavy fretting, and severe corrosion of the inner surface of the coupling sleeve.

Failed L.P. turbine coupling

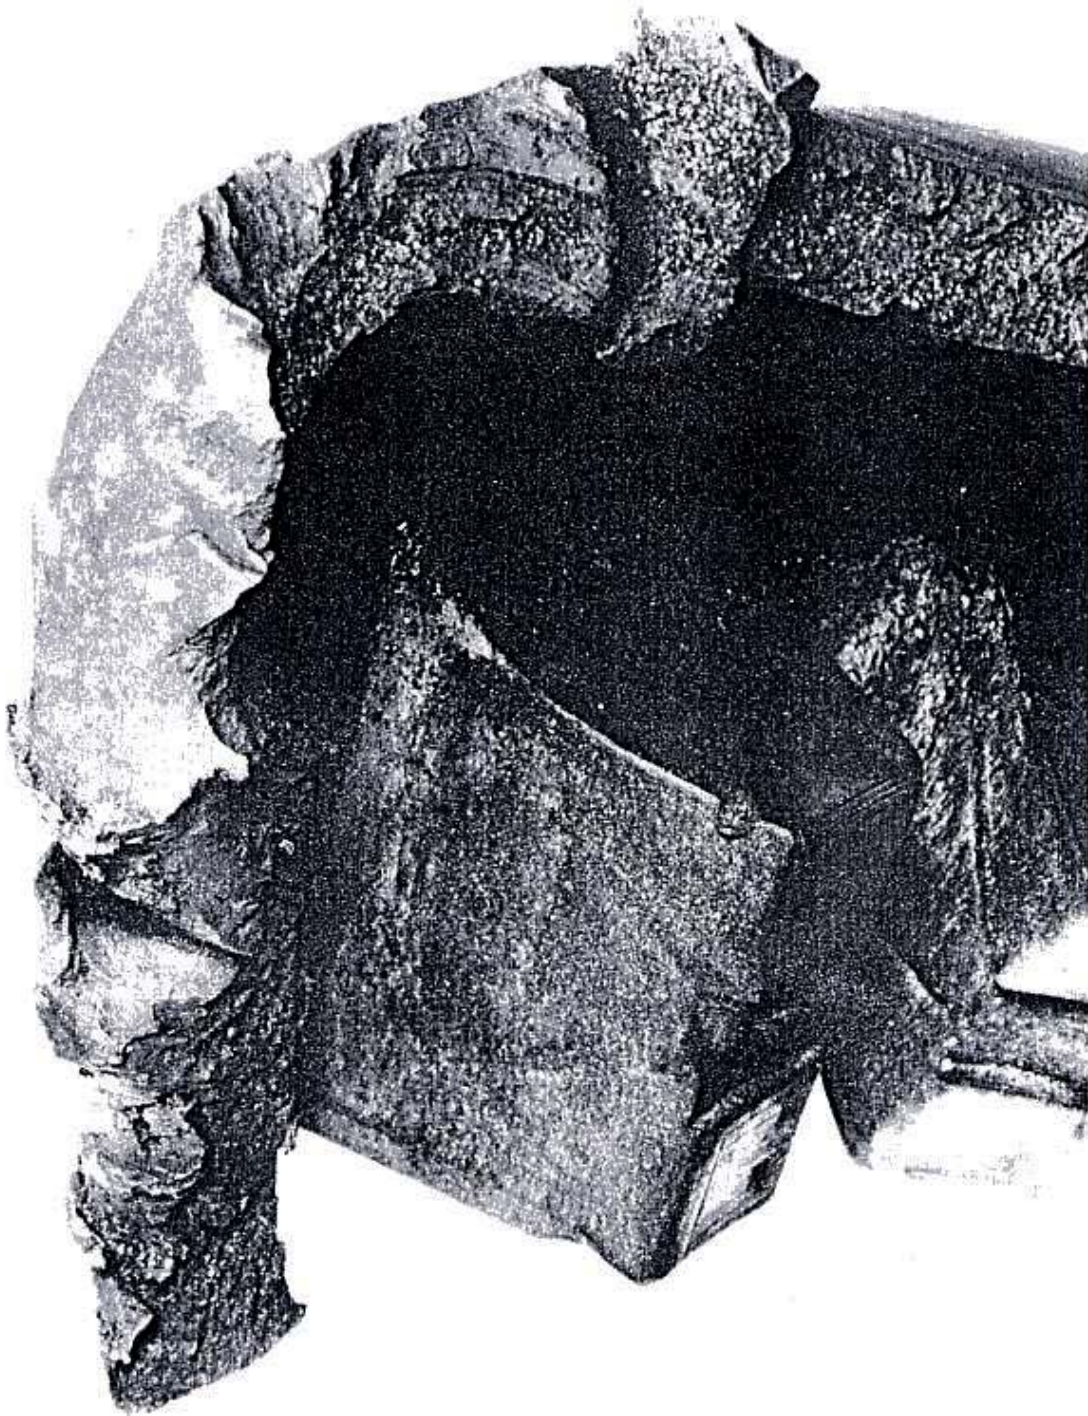
Figure 2b

Position of broken tooth

Failed L.P. turbine coupling

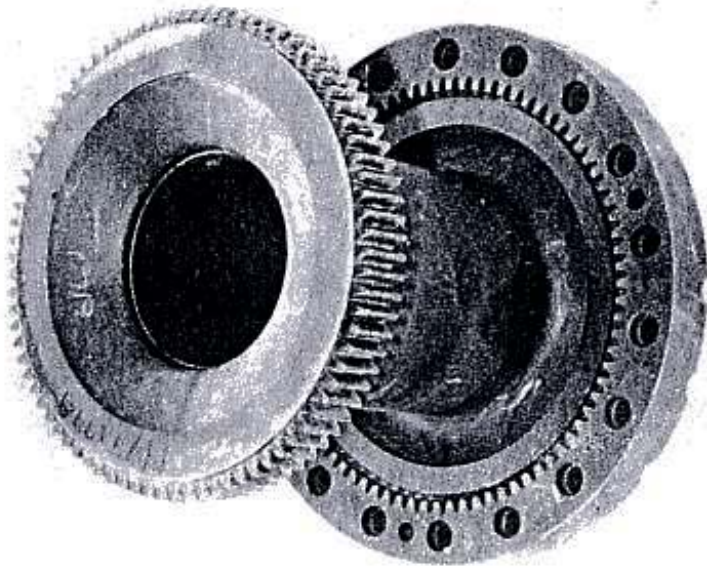
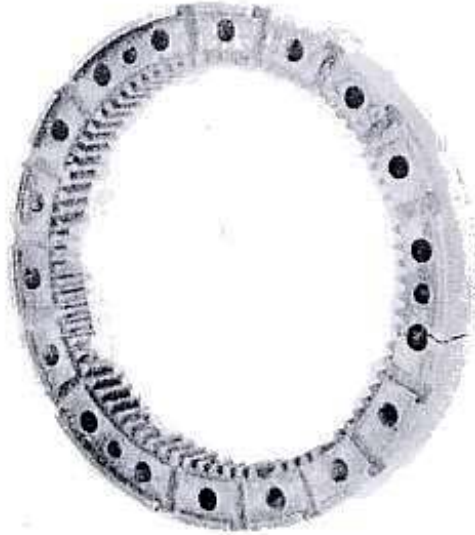
Figure 3a

General appearance of failure

Failed H.P. turbine coupling

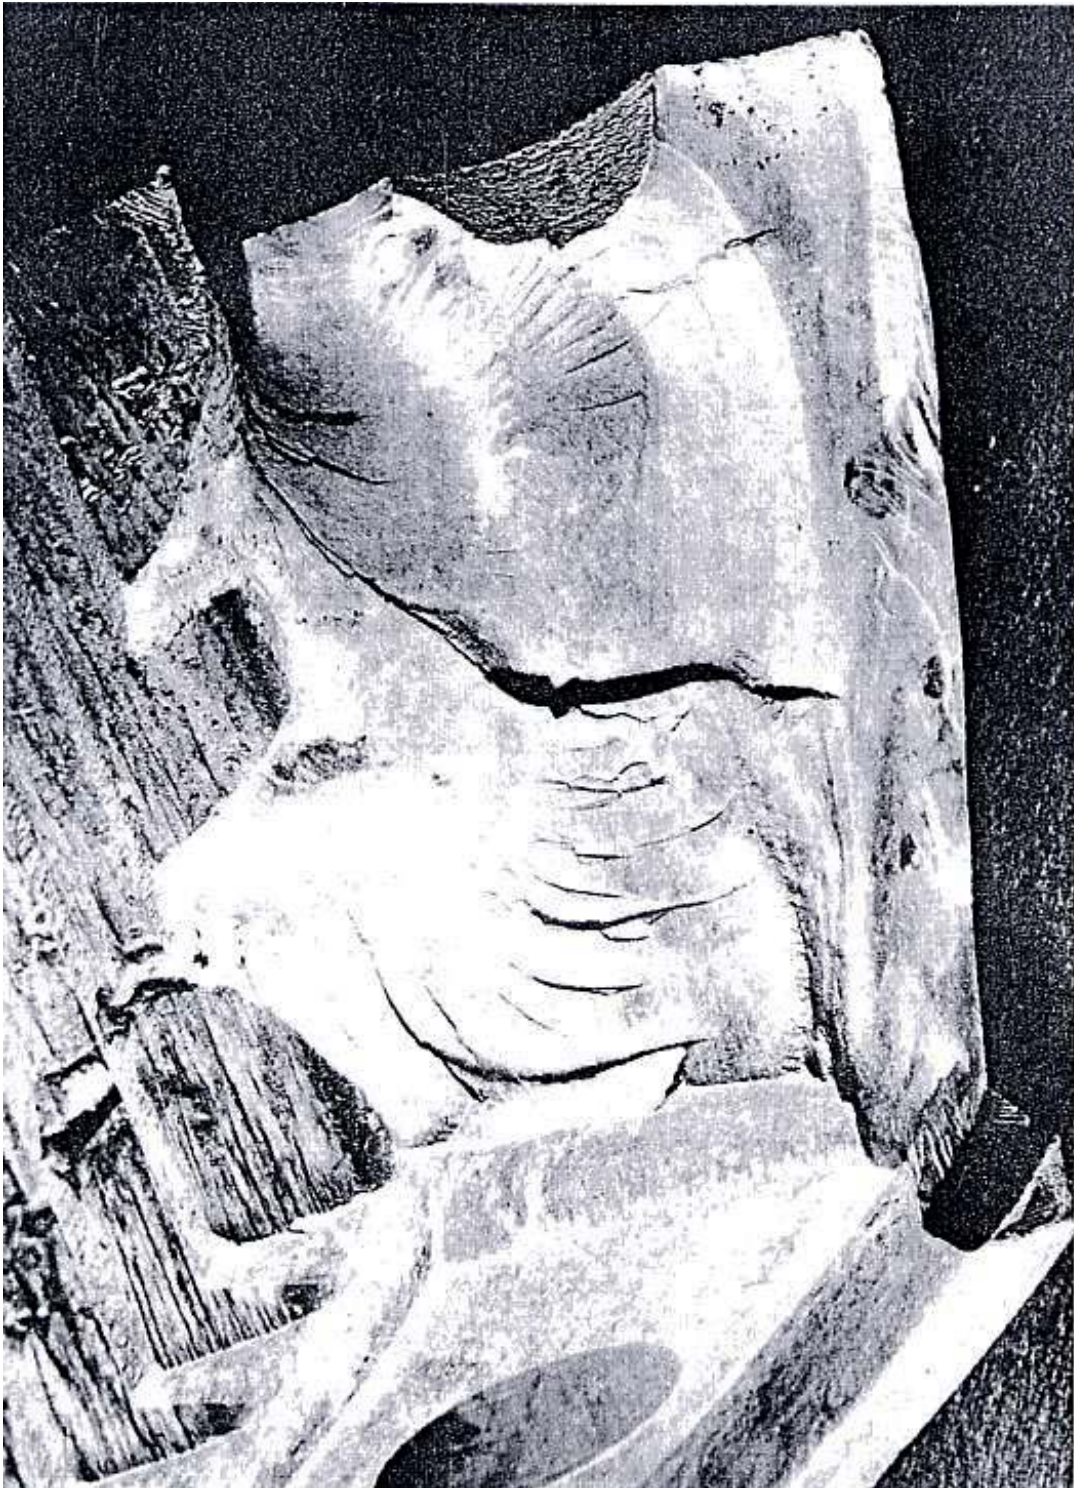
Figure 3b

Close up of fatigue fracture

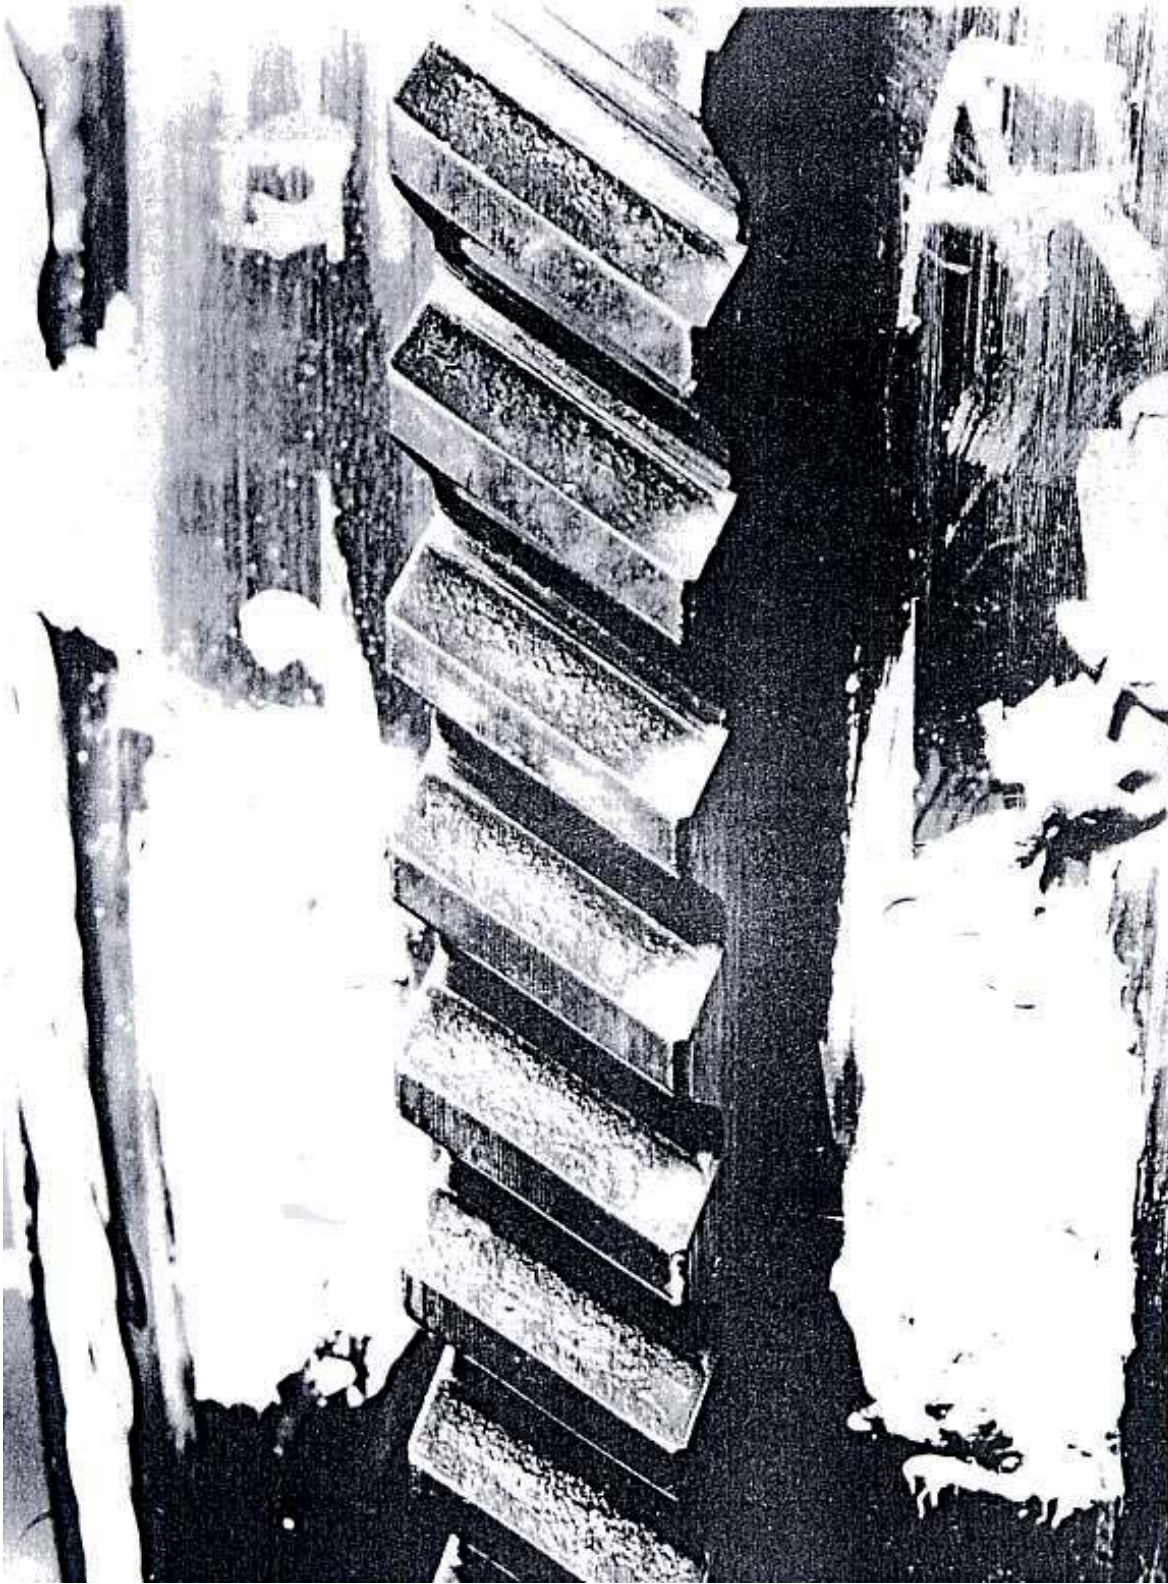
Figure 4

units. This is the well known Stal-Laval AP design, which was introduced in 1965. It is interesting to note that modern Stal-Laval engines incorporate not only gear type flexible couplings, but also the membrane type in the output between the first and second reduction epicyclic gearing and, finally, geared rings in the coupling system of the epicyclic units. The coupling rings serve to support the epicyclic gears, and provide a connection to the gear casing. Service experience with these rings over periods up to 11 years has shown that fretting develops in the early stages, and often the condition of the components appears unsatisfactory. However, the condition stabilizes, and coupling replacements have not been found necessary in the large majority of ships (see Figure 4).

Fretting of coupling ring teeth
