Marine Gear Type Couplings in Service

D.L. Saunders-Davies

Shell International Marine Limited, London, England.

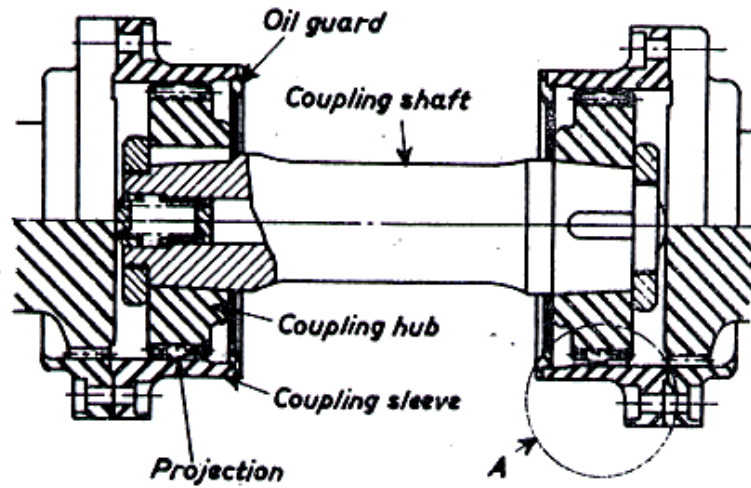
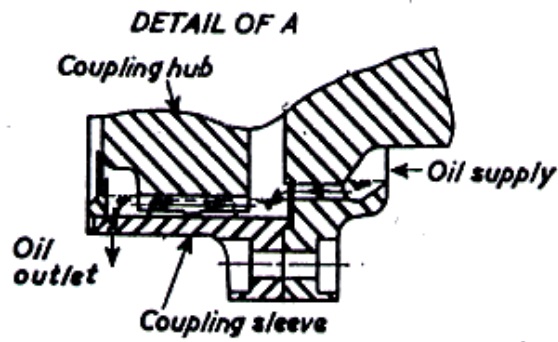
Fig. 6 —Sectional view of flexible coupling

At one time the lubrication system, so-called, for flexible couplings was a pure act of faith. Far more attention is now paid to making sure that ample lubricant reaches the teeth, and that a flow exists to flush away any debris and the inevitable sludge resulting from the centrifuging action of the coupling at high speed. Even so, there is a tendency for the oil to flow preferentially through the unloaded side of the mesh where there is less resistance to flow. A good design of oil system, made by a Japanese turbine manufacturer, is illustrated in Figure 6.
